Kilkenny Central Access Scheme

Follow-up Aquatic Ecological Report

6th October 2014

Prepared on behalf of John Craddock Ltd.

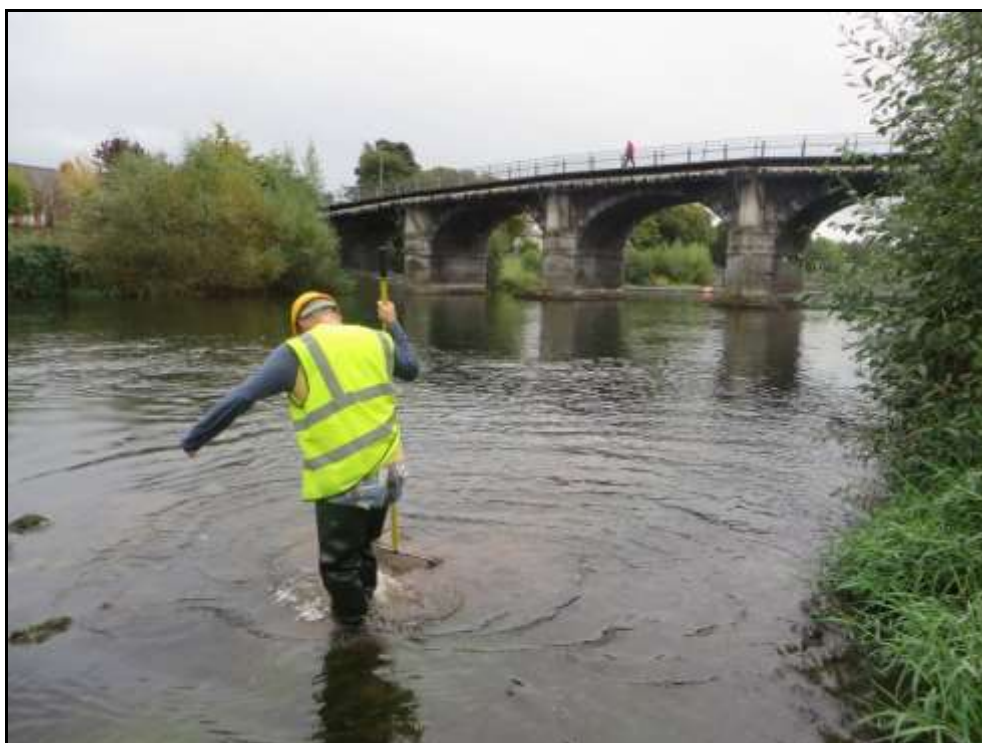
Plate 1 Biological sampling in the River Nore upstream of Green's Bridge at the Control site (Site 2).

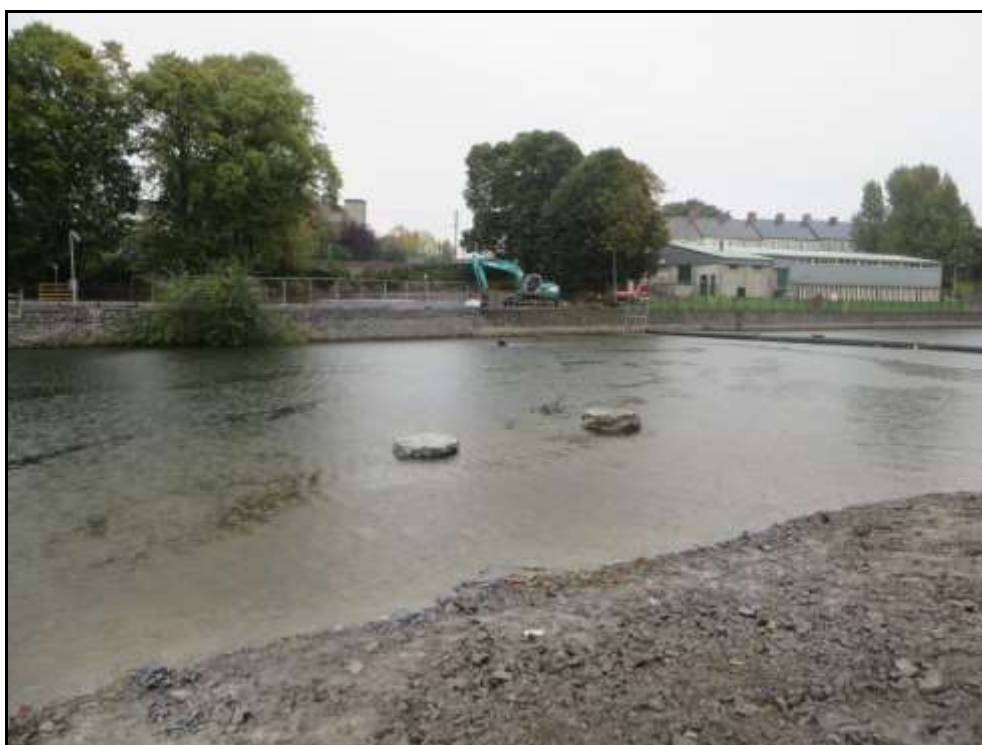
Two structures have been constructed within the river approximately 5m from the right bank. The right bank of the river has been denuded and covered with limestone aggregate. Bare soil also occurs in this area. The riverbed within the footprint of the works has been significantly altered. Stone (limestone) has been introduced to the river. Large piles of submerged stone were recorded at both the right and left sides of the river. On the right side of the channel, this stone extends for a distance of approximately 25m longitudinally (upstream to downstream) and over half way across the river (from the right bank). The coverage of newly introduced instream stone on the left side of the channel is approximately 10m longitudinally and 7m across. There was evidence that the bed of the river between these areas had been affected by the works i.e. stones had been introduced to the riverbed and had been subsequently removed.

Plate 2 The River Nore at the location of the new bridge. Two structures have been constructed within the river. The riverbed in this part of the river has been significantly altered.

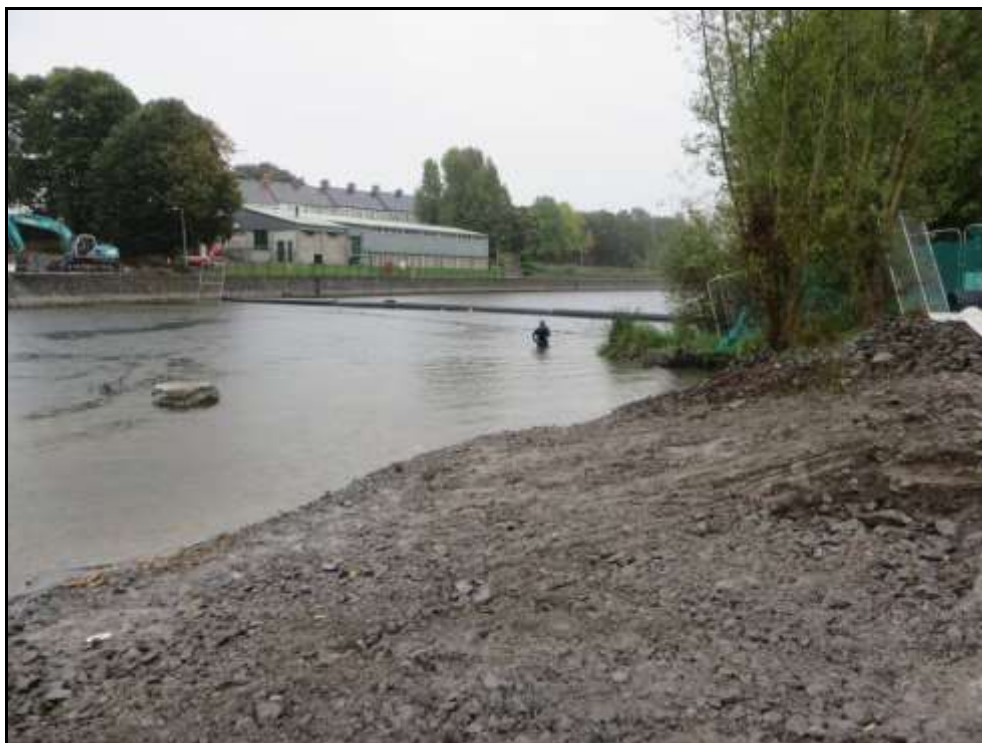
Plate 3 Bare aggregates and soil on the right bank of the river.

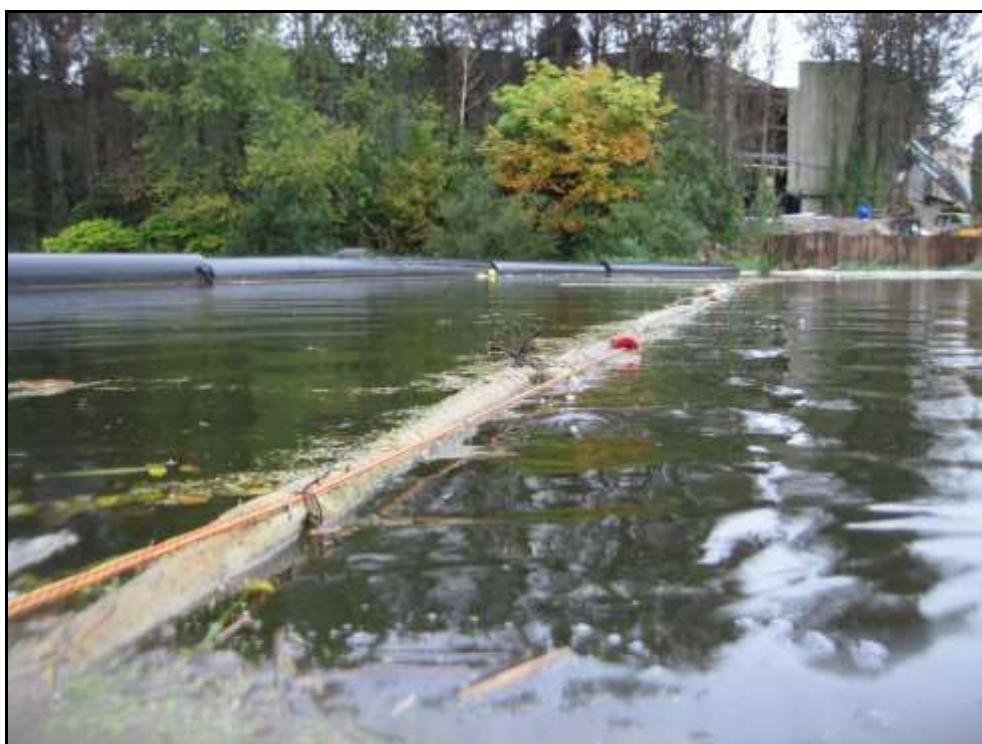
The works undertaken for the Kilkenny Central Access Scheme to date have included instream and riparian works. The part of the river affected by the works has been blocked off, with floating plastic piping positioned across the river upstream and downstream of the works area. A boom was positioned across the river downstream of the works location within this area.

Plate 4 Boom positioned across the river downstream of the works.

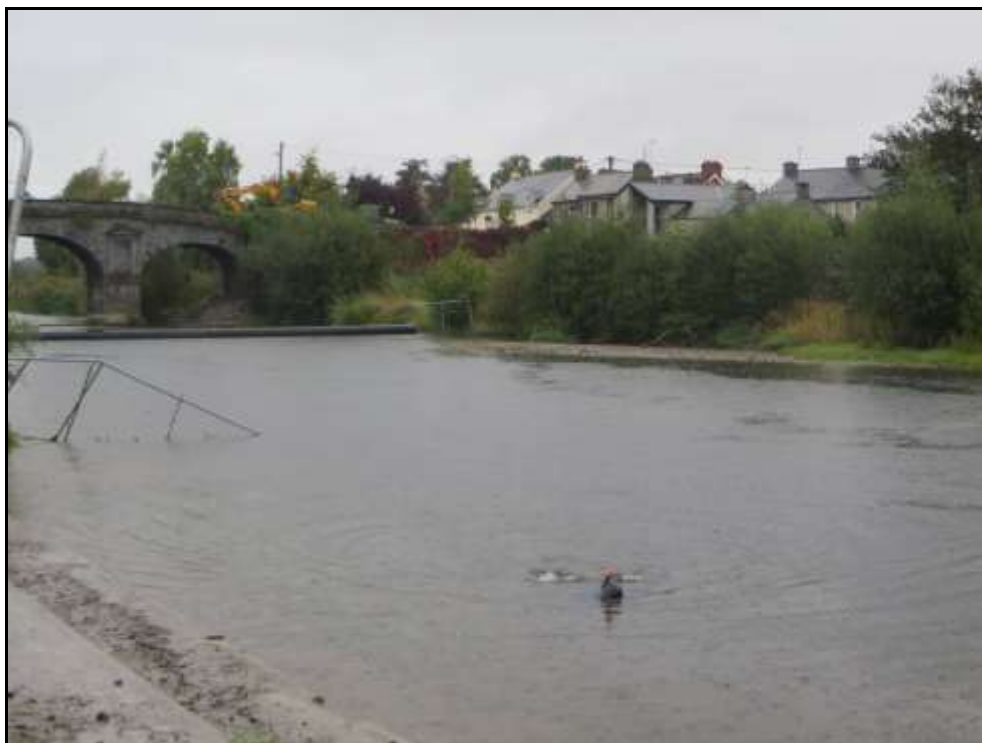
No aquatic plant life was recorded at the proposed bridge crossing site (Site 1). All plant life has been covered, or removed. Previously recorded aquatic plant life at this location was floating sweet grass *Glyceria fluitans*, curly pondweed *Potamogeton crispus*, Waterweed *Elodea* sp., water starwort *Callitriche* sp., aquatic moss *Fontinalis* sp. and filamentous algae *Cladophora* sp. Aquatic flora at Site 2 upstream of Green's Bridge was the same as recorded in the July survey (Water crowfoot

Plate 5 No aquatic plant life was recorded within the footprint of the development during the snorkelling survey.

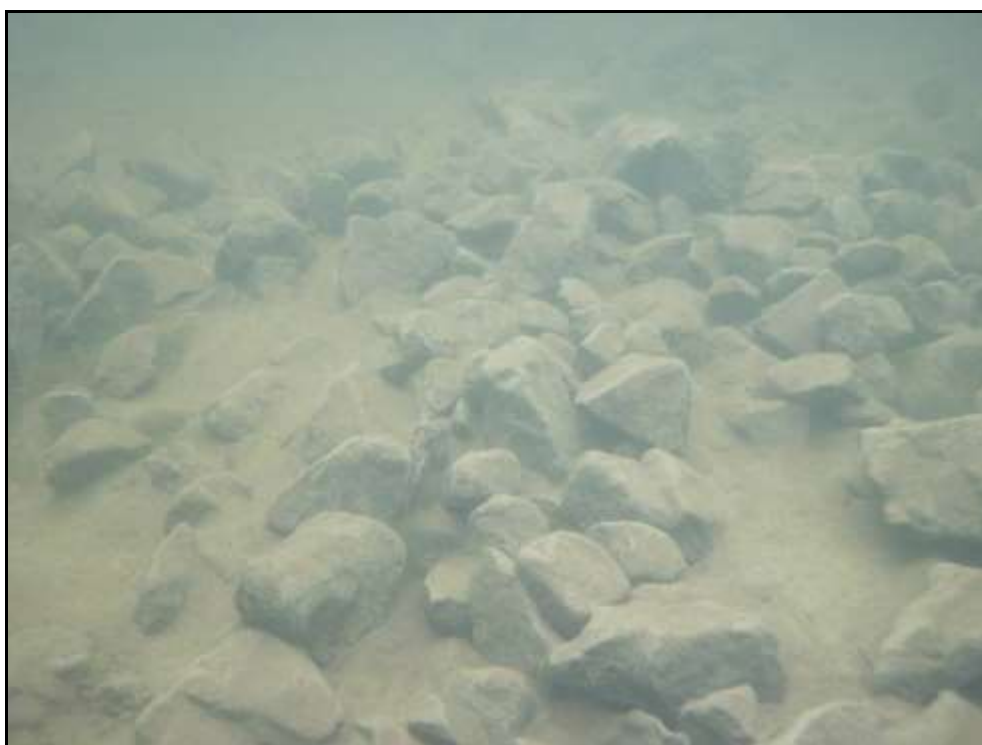
The riverbed within the footprint of the works had a thick layer of deposited silt. This siltation was significant within the works area and completely covered the substrate in places. This siltation extended a considerable distance downstream. Indeed, an examination of the river approximately 700m downstream of the works indicated recent suspended solids pollution - the substrate in the River Nore immediately upstream of Lacken Weir had a heavy coat of silt.

Plate 6 Underwater view of the River Nore at the new bridge crossing point. All aquatic life has been covered, or removed. Substrate in the River Nore at the crossing point of the new bridge currently comprises introduced stone and a layer of deposited silt.

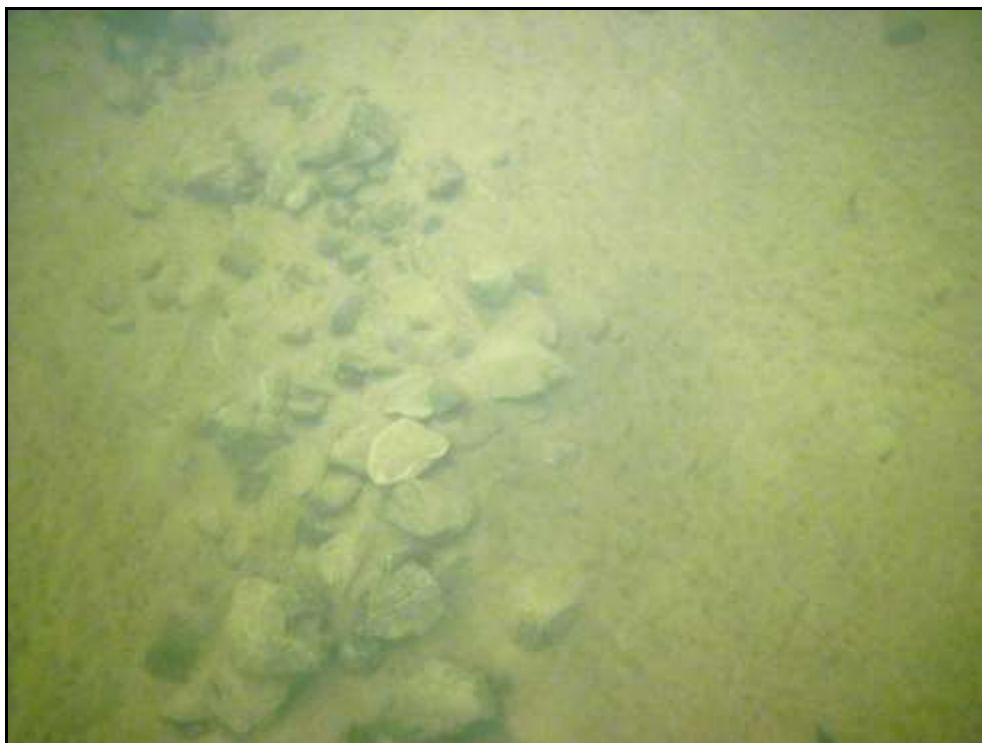
Plate 7 View of the centre of the River Nore at the crossing point. There was evidence that the bed of the river beyond the existing piles of stone had been affected by the works i.e. stones had been introduced to the riverbed in other areas between same, and had been removed.

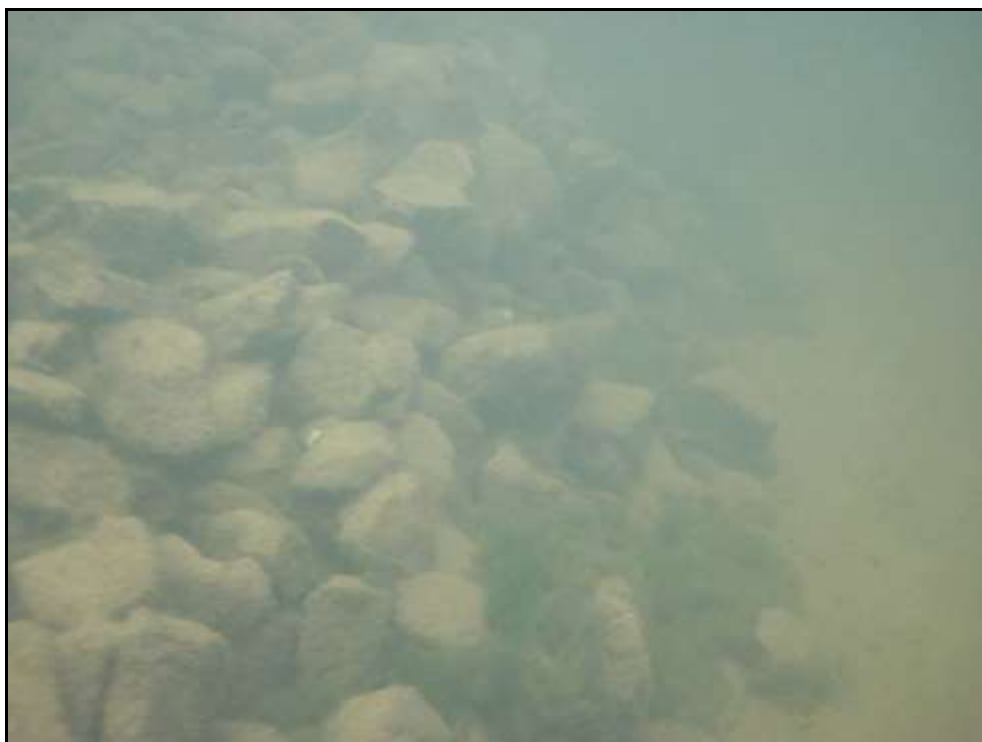
Plate 8 A large pile of stones occurs in the river at both the left and right side of the river at the crossing point.

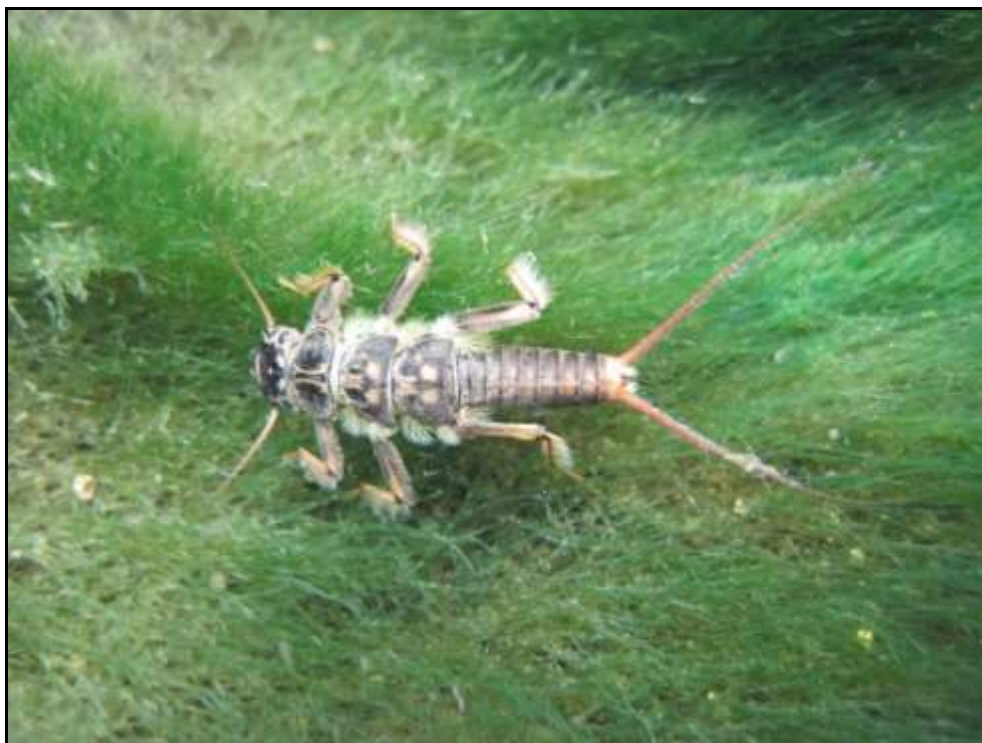
Plate 9 Larvae of the pollution sensitive stonefly *Perla bipunctata* was recorded in riffled habitat upstream of Green's Bridge (Control site).

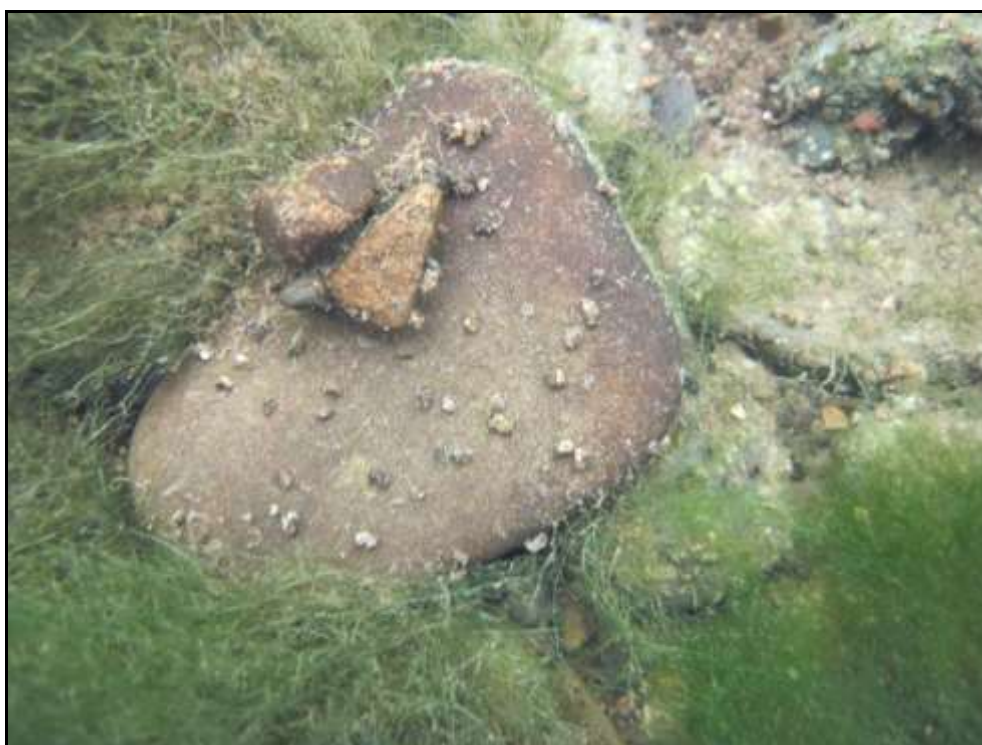
Plate 10 The River Nore supports a diverse macroinvertebrate community at the Control site. Larvae of the cased caddisfly *Agapetus fuscipes* (Group B: less pollution sensitive indicator) can be seen attached to the overturned rock.

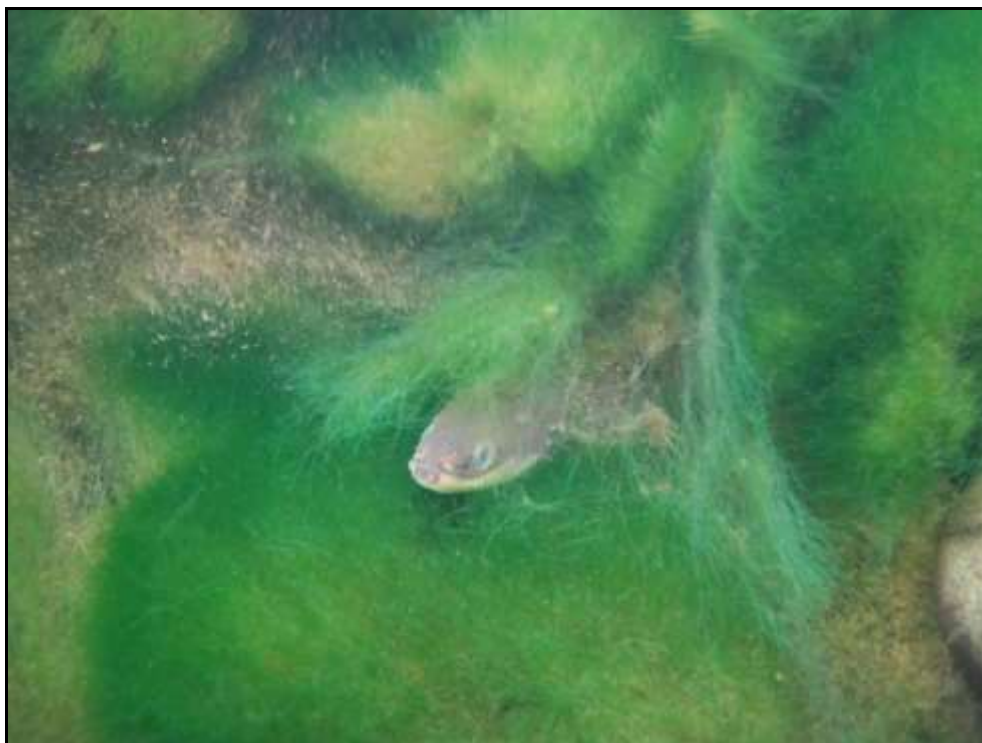
Plate 11 The European eel *Anguilla anguilla* was recorded in the river at Site 2. Suitable habitat for this endangered species occurs in the river within the study area.

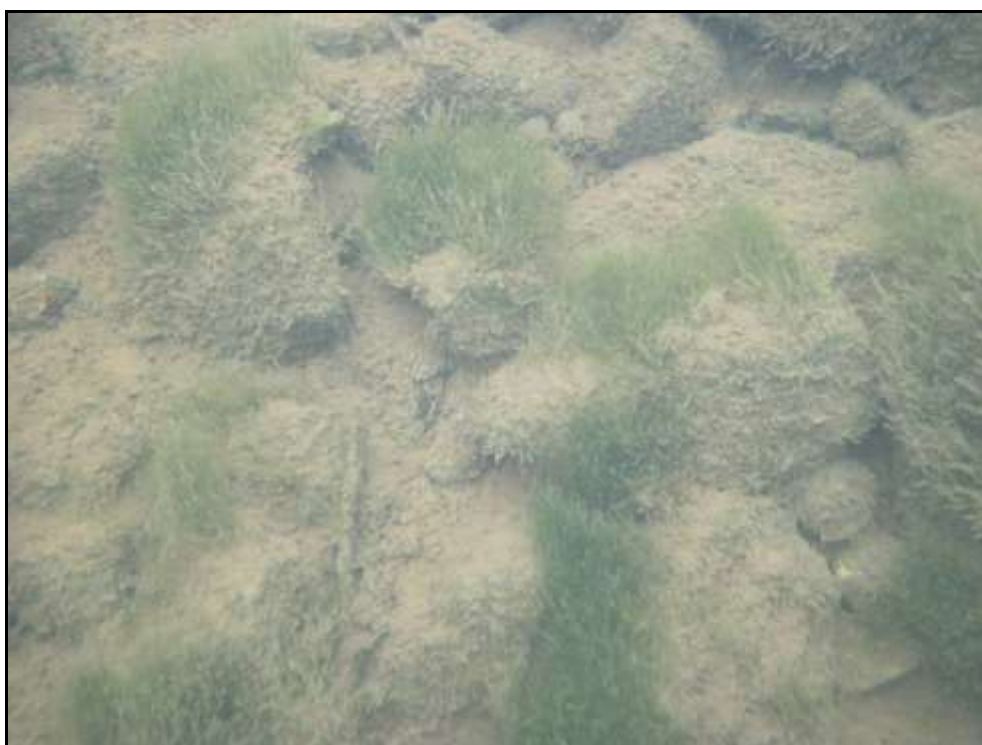
The River Nore within the works area and downstream, at least as far as Lacken Weir, has been adversely affected by the recent instream works at the crossing point of the Kilkenny Central Access scheme. Within the works area, the riverbed has been completely changed with the introduction of limestone. The habitat quality of the river downstream of the works area has been seriously degraded as silt has covered the substrate in close proximity to the works, and is deeply embedded within the substrate to within 700m downstream. In advance of the instream works the river at Site 1 supported 17 families of macroinvertebrates. In the most recent survey no macroinvertebrates were recorded at this location despite extensive searching. Macroinvertebrate habitat has been obliterated as a result of the instream works within the footprint of the development. There are also no aquatic plants present at the bridge Crossing site.

Plate 12 Substrate of the River Nore immediately upstream of Lacken Weir. This photo indicates recent Suspended Solids pollution. This part of the river is approximately 700m downstream of the crossing point.
